# DAWN-FC

## Dawn FC DC034 Report

DA-FC-MPAE-RP-285 / 1-

16/December/2009

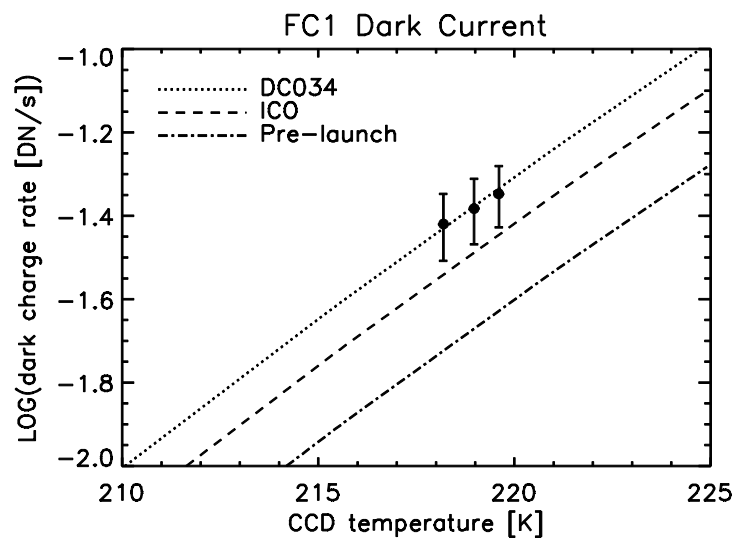
Figure 1: Comparison of FC1 dark current with previous measurements.

The percentage of hot pixels is now 1.5 %, defined as pixels that have dark current larger than bulk mean plus 4 sigma. This is up from 0.32% during the ICO calibration campaign. The increase is 20% smaller than expected from ICO results, perhaps due to increased distance to the Sun.

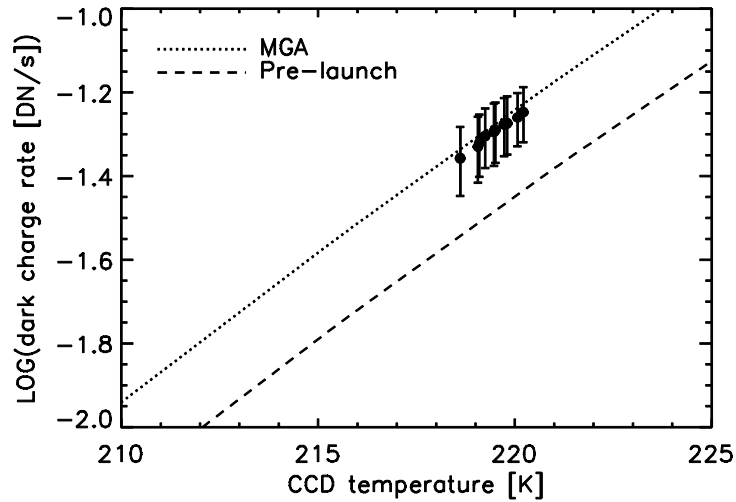
**Figure 2: Comparison of FC2 dark current with previous measurements.**

The bulk dark current, shown on Figure 2, is consistent with that determined during ICO/MGA (dotted line). The images for this analysis were taken from the VIR geometric cross-calibration activity.

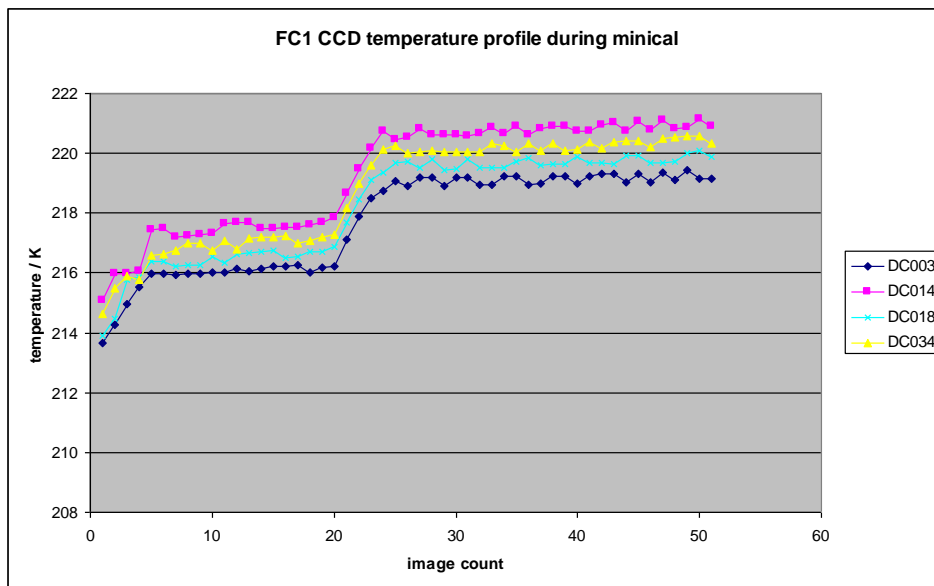
**Figure 3: FC1 CCD temperature profile during mini-cal.**

The CCD mini-cal has been executed for the purpose of extra charge determination four times on each of the FCs including DC034, as summarized in Table 1 and Table 2. The temperature variations between the different runs lie within a 2 K band for FC1 and a 4 K band for FC2 and the temperature profile shows the same shape in all cases.

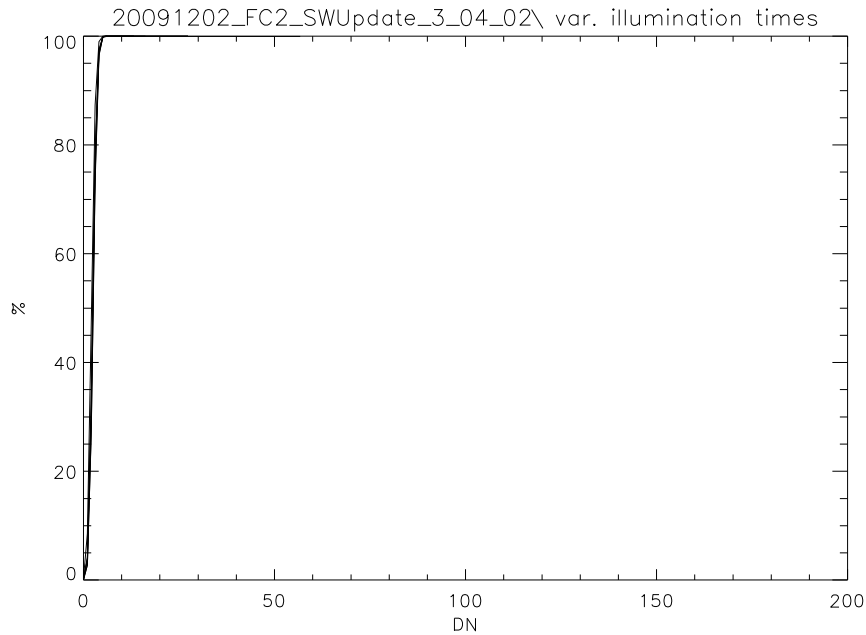
**Figure 5: Accumulated histogram for FC2 cal-lamp images.**

For FC2 no extra charge at all was found at the signal levels provided by the calibration lamp in DC034 or any of the previous runs. The accumulated histogram in Figure 5 shows the readout noise but absolutely no indication of extra charge.

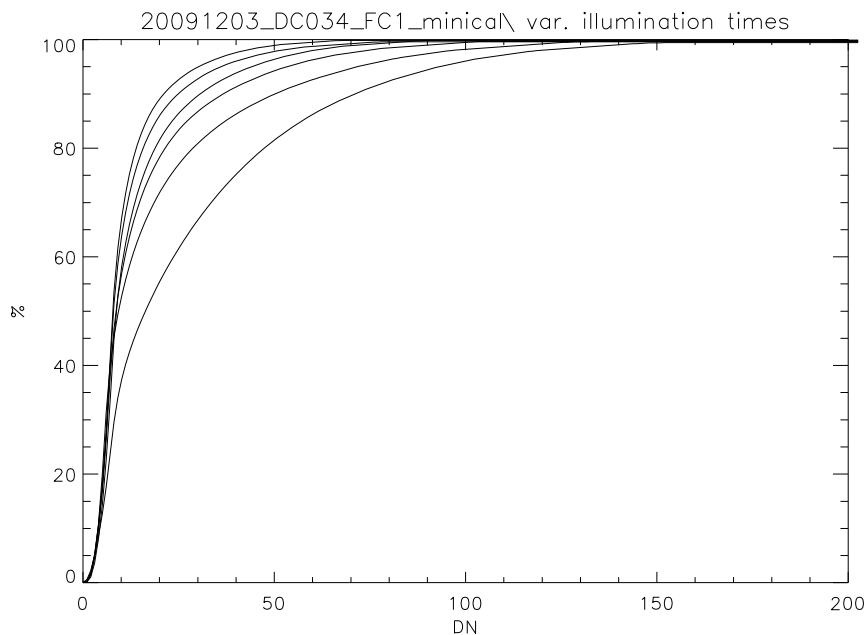
**Figure 6: Accumulated histogram of extra charge on FC1 at six different pre-illumination times.**

The accumulated histograms for FC1 data show extra charge distribution of pre-illuminated cal-lamp images (Figure 6). The signal level of the most affected pixels goes up to 200 DN. The cal-lamp images were acquired with pre-illumination times of 1, 2, 3, 5, 10 and 60 seconds (plots from top to bottom show increasing pre-illumination times).

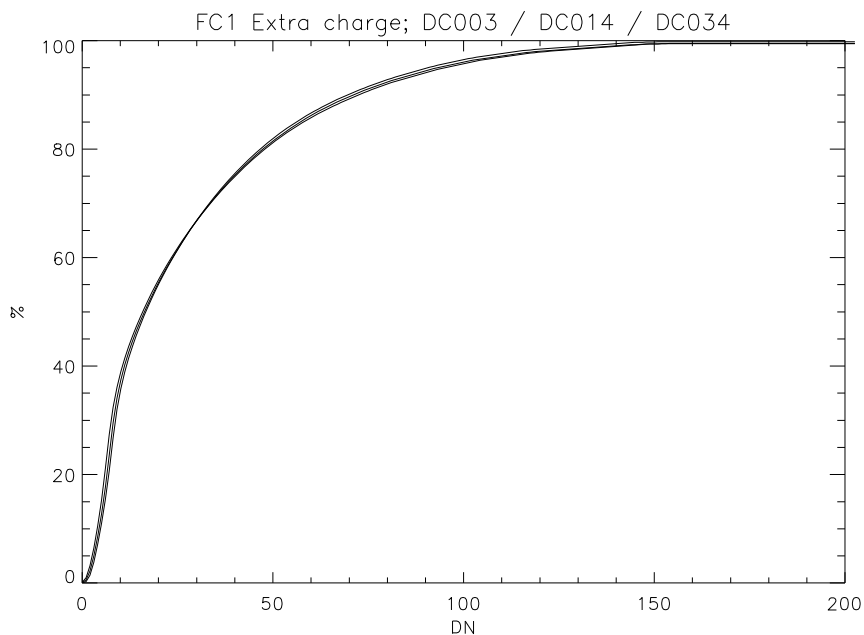
**Figure 7: Comparison of the 60 s pre-illumination extra charge histograms**

The comparison of the 60 s pre-illumination images from DC003, DC014 and DC034 (Figure 7) show no significant change in the amount of extra charge on the FC1 CCD. DC018 is missing in

this comparison because it was executed with pre-clear of the CCD, thus rendering the images unsuitable for comparison.

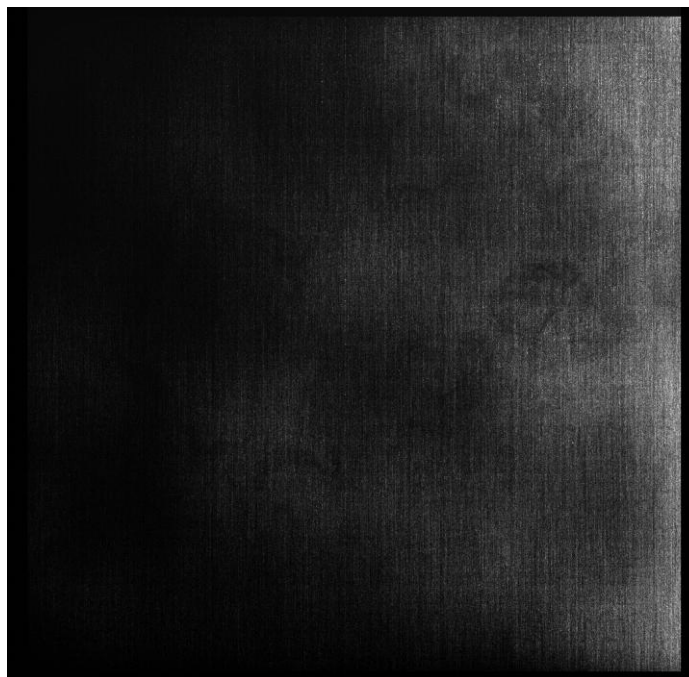
**Figure 8: Typical extra charge pattern on FC1 (0, 0 at bottom left).**

The typical signature of the extra charge on FC1 is shown on Figure 8
