DAWN - Framing Camera

DC014 Report

DA-FC-MPAE-RP-287

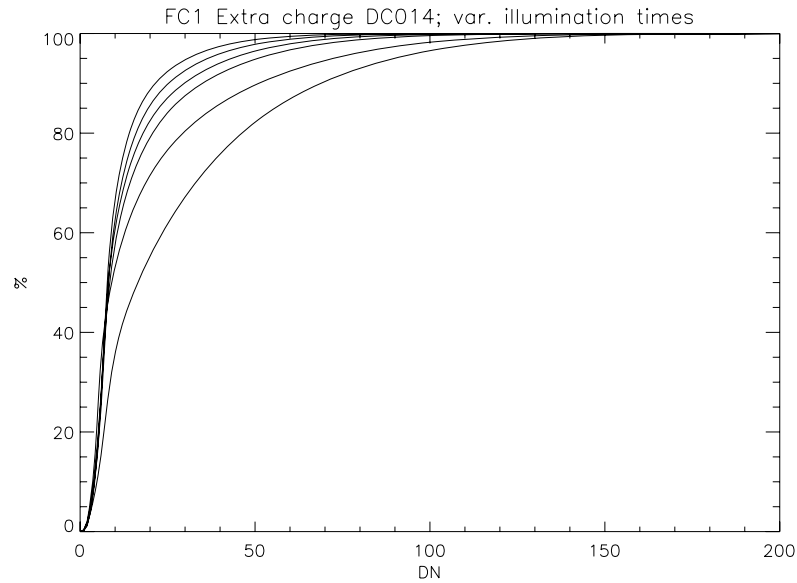
As already detected earlier the extra charge on FC1 could be verified to be still present and not having changed significantly.

The extra charge measurements during DC014 were done with different pre illumination times, allowing the extra charge to accumulate prior to the exposure. Figure 1 shows the accumulated frequency of DNs all the 1024x1024 pixels. The six different graphs show the level of extra charge for six different illumination times (from bottom to top: 1.3 s, 2.3 s, 3.3 s, 4.3 s, 6.3 s, 11.3 s). The most effected pixels show extra charge of up to 200 DNs.

Figure 1: Accumulated histogram of pixels showing extra charge on FC1

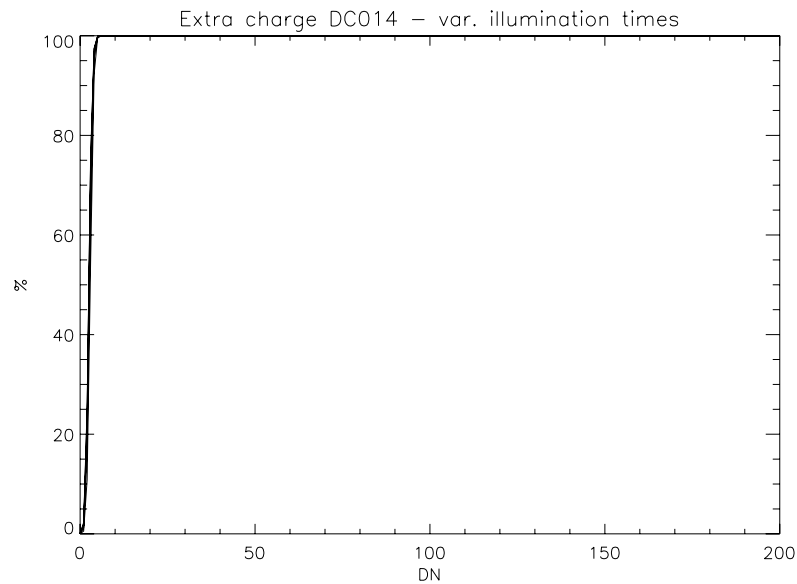
No traces of extra charge could be found on FC2 during DC014. Figure 2 shows only the up to 5 DN noise consisting of readout noise and photon noise.

Figure 2: Accumulated histogram of pixels does not show any extra charge on FC2

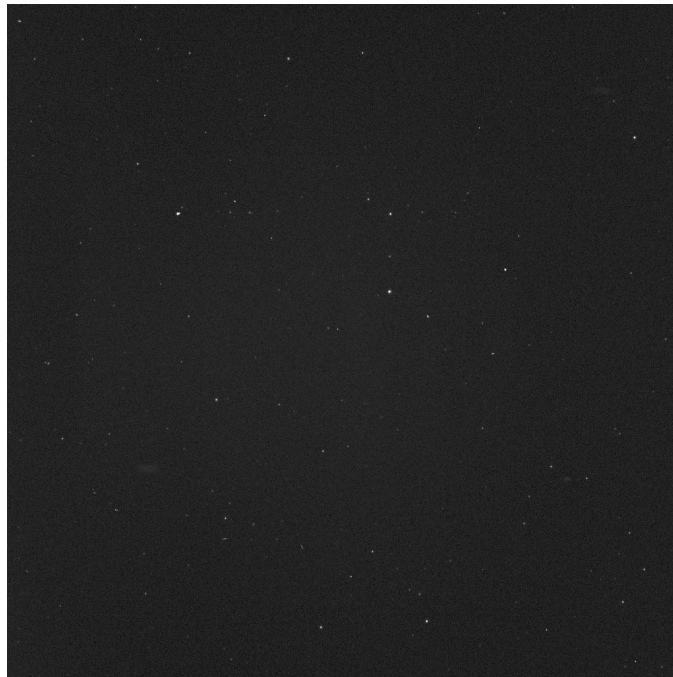
Several streaks were identified in the images taken during this operational slot. The following table identifies the images where one or more were found.

Figure 3: Three streaks on FC2_2008-04-03T02.39.12.707Z_ID10_0000000882_F1

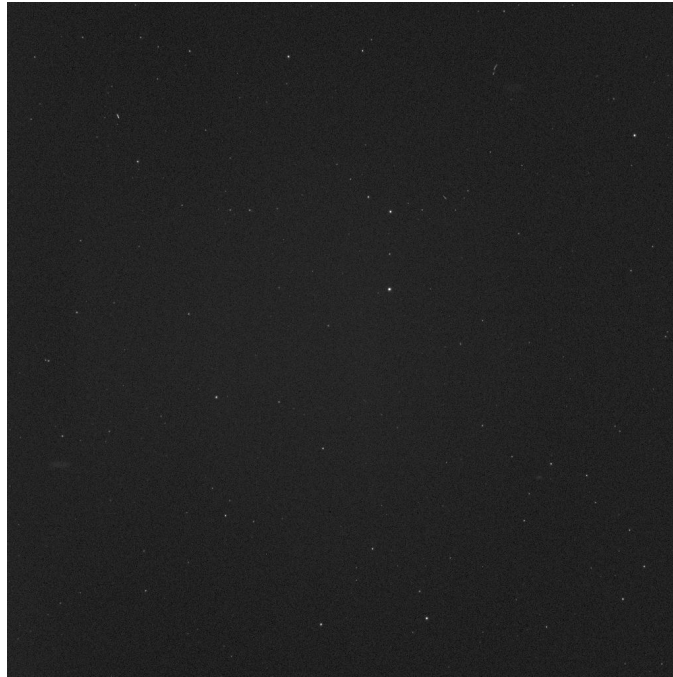
Figure 4: Three streaks on FC2_2008-04-03T02.39.27.845Z_ID10_000000883_F1

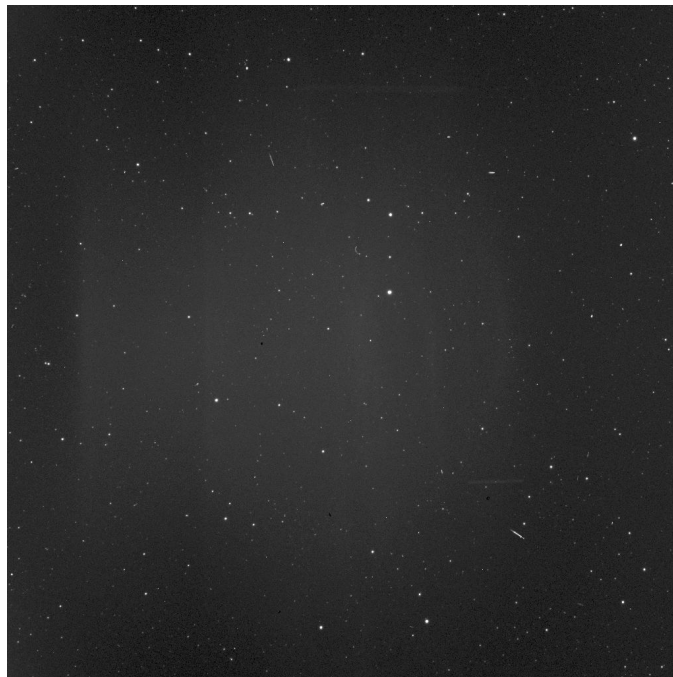
Figure 5: Two streaks on FC2_2008-04-03T02.39.38.025Z_ID10_000000884_F1

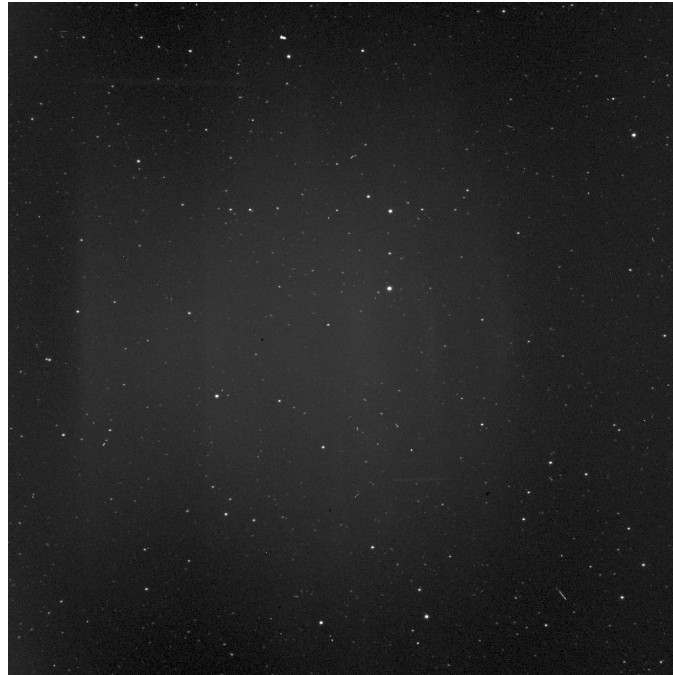
Figure 6: Two streaks on FC2_2008-04-03T02.40.17.810Z_ID10_000000885_F1

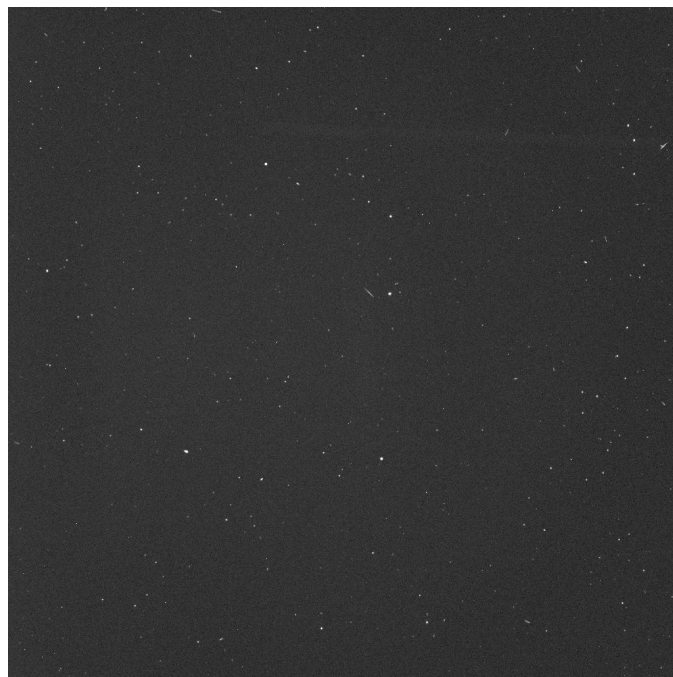
Figure 7: One streak on FC2_2008-04-03T02.49.17.694Z_ID10_000000897_F7
