DAWN - Framing Camera

Framing Camera ICO Report

DA-FC-MPAE-RP-268 / 1d

25 June 2008

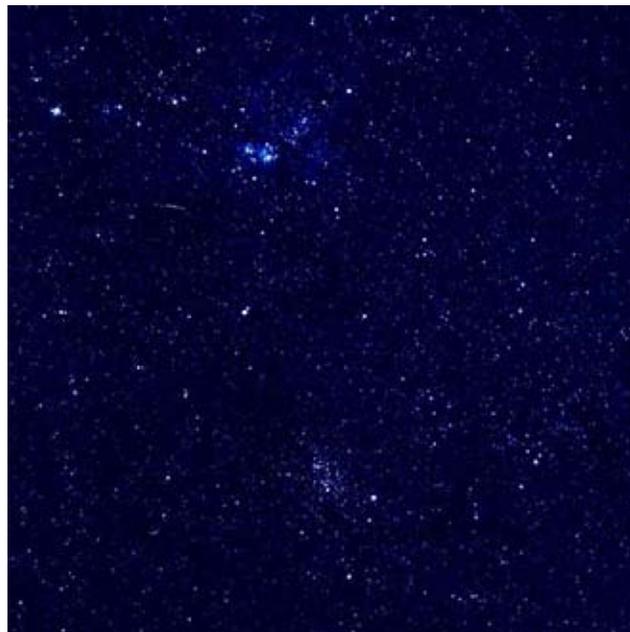
Image 408 shows a second segment of missing data:

The first packet after resuming the playback was 8071, with SCLK 250006543:031 (250006543 seconds 513327104 fractions). This packet included ULONGs [28111, 28362] of the image.

The attached file FC21A0000408_07338020630F1A.raw is the image as it was received on ground (prior to decompression). A row of zeros can be seen in the middle of compressed data starting at byte 112458 (ULONG 28114) until byte 113448 (ULONG 28362).
